NATIONAL DAM SAFETY PROGRAM. LOWER MOUNT GLEN LAKE DAM (NJ00011--ETC(U)

LOWER MOUNT GLEN

PHASE I INSPECTION REPORT

NJ 00011

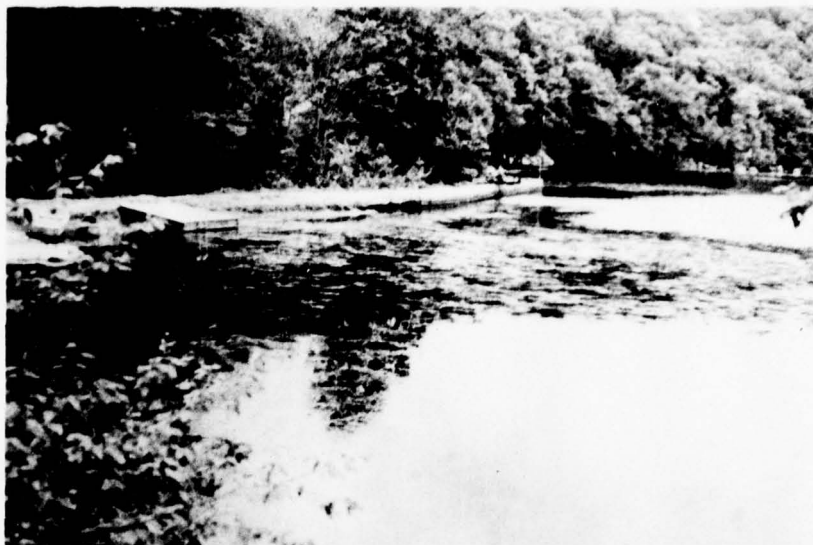
Photo 1 -
View of dam
from upstream
near left
abutment.

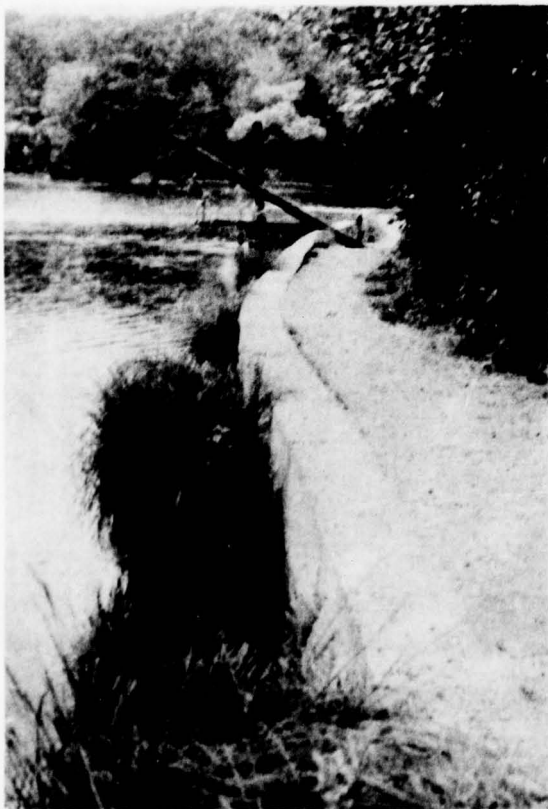
VISUAL EXAMINATION OF	OBSERVATIONS	REMARKS OR RECOMMENDATIONS
SURFACE CRACKS	Embankment heavily covered with brush and vines. No evidence of surface cracking can be found. Core wall eroded near outlet vault exposing rock masonry core.	Remove brush and vines from slope and toe of embankment. Repair core wall and backfill both sides of core wall.
UNUSUAL MOVEMENT OR CRACKING AT OR BEYOND THE TOE	No surficial evidence of movement or cracking at or beyond toe.	
SLOUGHING OR EROSION OF EMBANKMENT AND ABUTMENT SLOPES	Wave erosion appears to have eroded upstream embankment to around plus or minus six inches of reservoir water surface. Downstream slope about 30 degrees. Irregular upstream and downstream. Maximum height of slope about 15 feet.	Backfill both sides of core wall and regrade crest.
VERTICAL AND HORIZONTAL ALIGNMENT OF THE CREST	No evidence of movement found.	
RIPRAP FAILURES	No riprap.

Photo 2 - View of top of core
wall and crest of
dam.

(4) The crest should be restored to the elevation called for in the 1965 plans. Properly compacted suitable fill material should be replaced upstream and downstream of the core wall at the slopes defined in the 1933 plan.

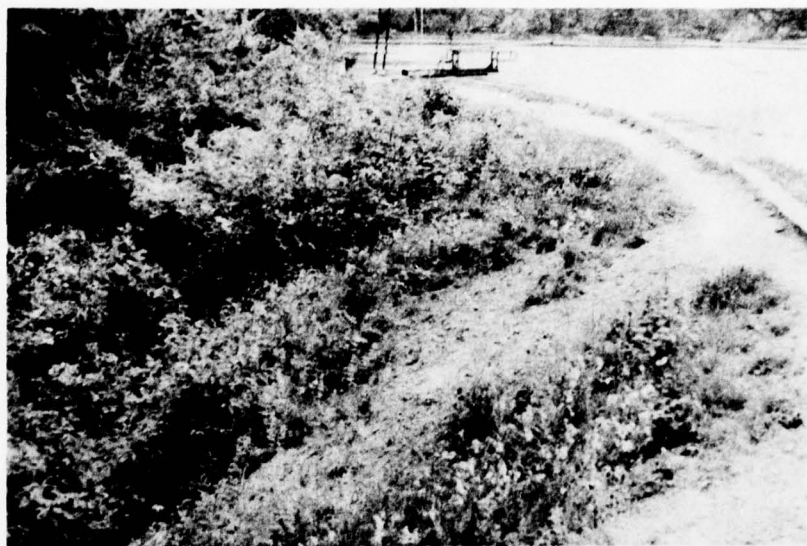
The embankment slopes are 1.5 to 1 upstream, and 2.0 to 1 downstream, and there are no signs of past or present downstream slope instability. Upstream slopes showed no evidence of instability above the waterline. Downstream slopes were heavily overgrown with brush and small trees. No evidence of holes dug by burrowing animals was found.

Photo 3 - View of downstream slope of dam showing heavy growth of shrubs and trees.

Surveillance and maintenance is in the hands of a few volunteer members of the owner association. At present, the owner association appears to face severe difficulty in obtaining the necessary funds to establish an effective program for maintenance and repairs. A formalized program of periodic inspection by an experienced party should be initiated, and documentation recorded to assist the owner association. A program for control of growth of trees and brush on the embankment and downstream channel should be initiated immediately.

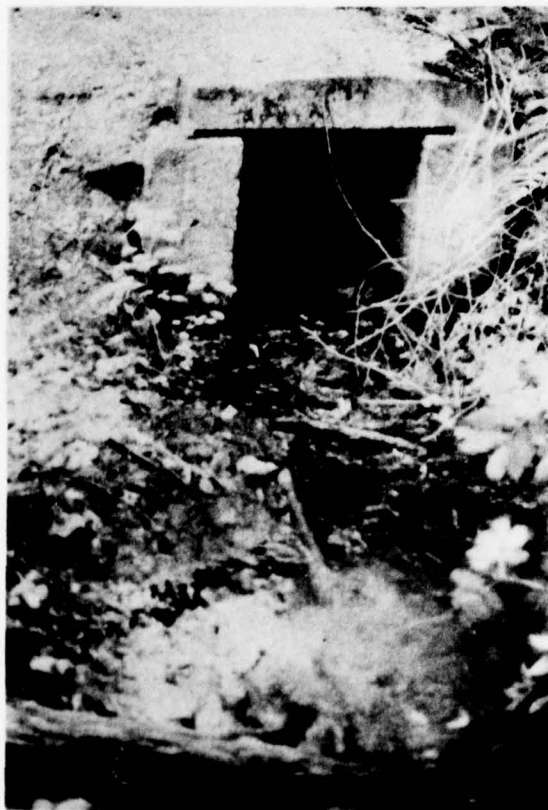
The exposed concrete box culvert end of the low level outlet is in good condition. The condition of the pipe under the upstream portion of the embankment could not be observed and is unknown.

Photo 4 - End of concrete box culvert discharge for low level outlet works.

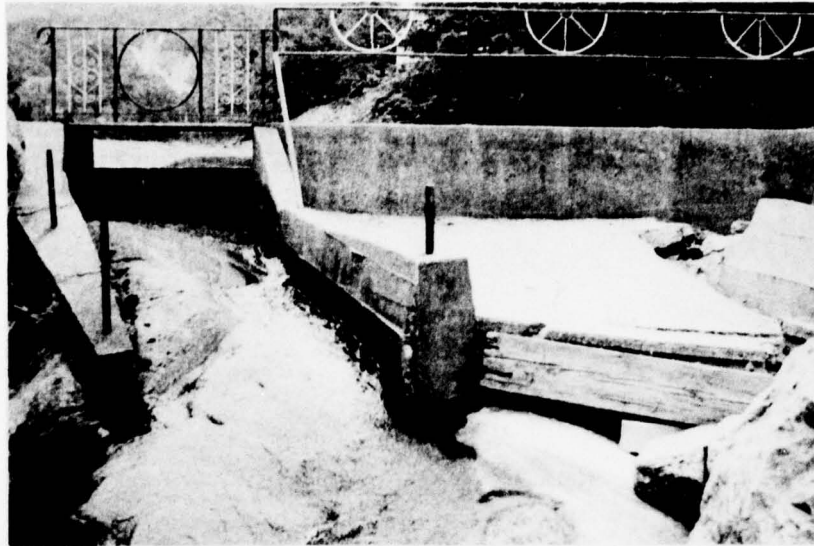
Photo 5 - Service spillway from downstream channel.

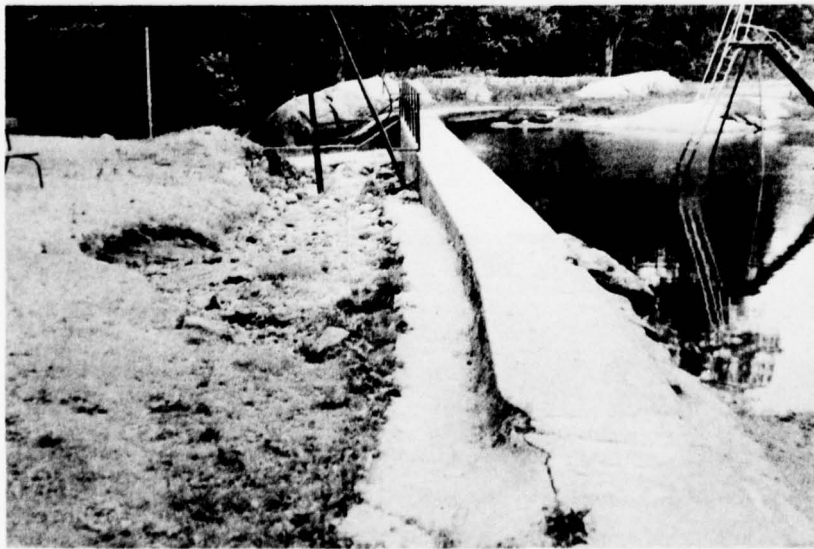
Considerable erosion was observed in the emergency spillway discharge channel which was constructed without any surface protection.

Photo 6 - Erosion behind low wall due to overtopping. Service spillway is at end of wall.

3. The erosion which has occurred downstream of the spillway wall should be repaired. An effective method of protecting the abutment from erosion by spillway discharges should be implemented. This work should be completed within 12 months.
4. The crest should be restored to the elevation called for in the 1965 plans. Properly compacted suitable fill material should be placed upstream and downstream of the core wall at the slopes defined in the 1933 plan. This work should be completed within 12 months.

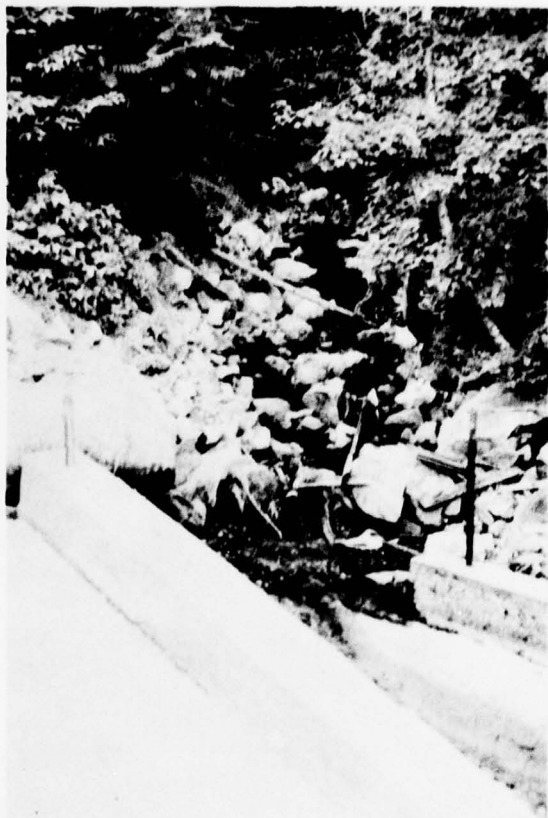
Photo 7 - View showing end of service spillway and discharge channel.

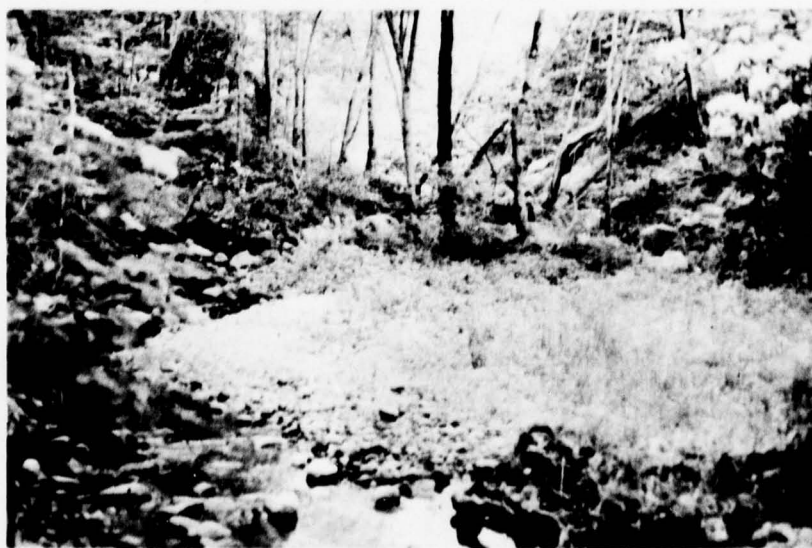
Photo 8 - View of discharge channel downstream from spillway.

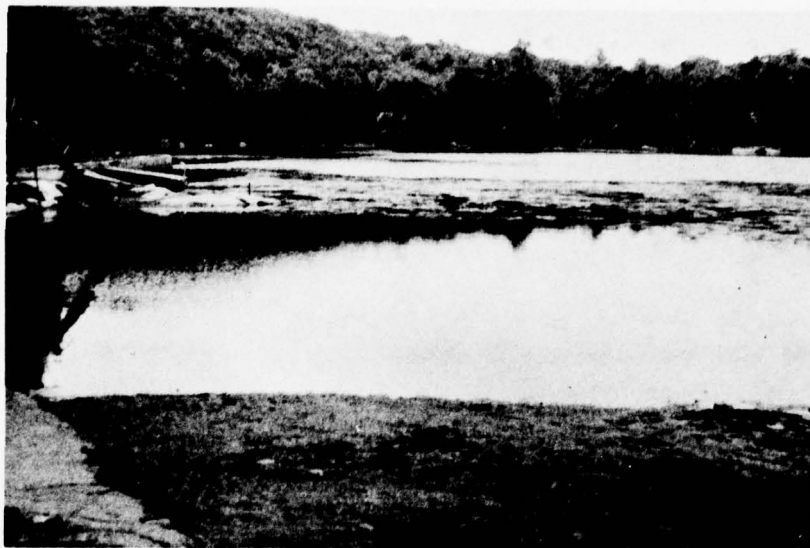
Photo 9 - View of lake with dam on left side of picture.
